Manhole Inspection Summary

Manhole # S35M__026MH

Insp Date: **3/25/08 11:49 AM**

Location Address: **601 light st**

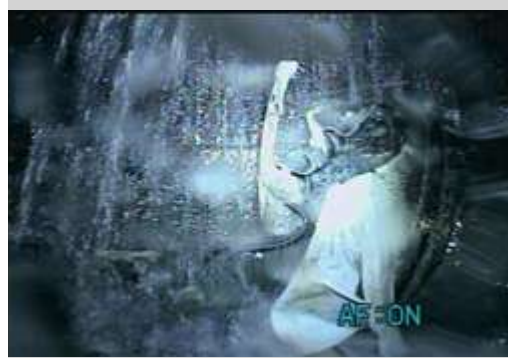
misc

bench debris

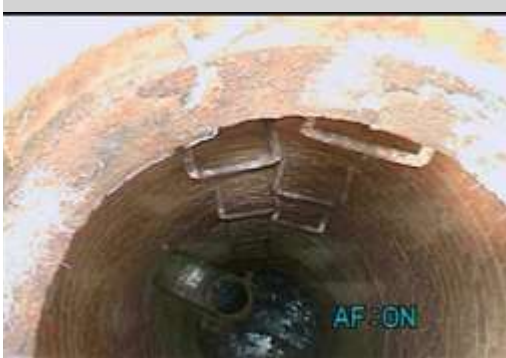
Defect 1

Count: **13** Missing: **0** ☒ **Corroded**

corroded steps

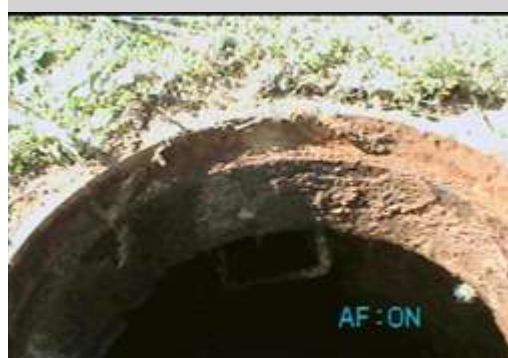
Defect

☒ **Leaks**

frame leaks

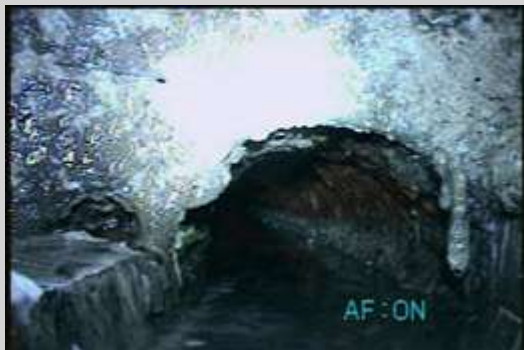
12 O'Clock Outflow

8 in. Circular Gravity Sewer
Pipe Out @ 12 OClock

Invert Depth: 19.96 (ft.) Flow Characteristics: Fast

Infiltration: None

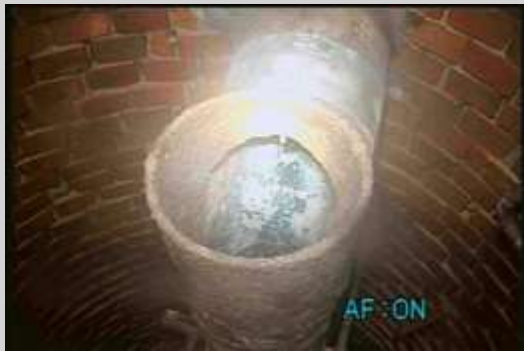
6 O'Clock Inflow

8 in. Circular Gravity Sewer
Pipe In @ 6 OClock

Invert Depth: 8.54 (ft.) Flow Characteristics: Turbulent
